NONDESTRUCTIVE EVALUATION OF DAMAGE
IN METAL MATRIX COMPOSITES

David A. Ulman, Edmund G. Henneke, John C. Duke,
Kenneth L. Reifsnider and Wayne W. Stinchcomb

Final Report
June 1, 1980

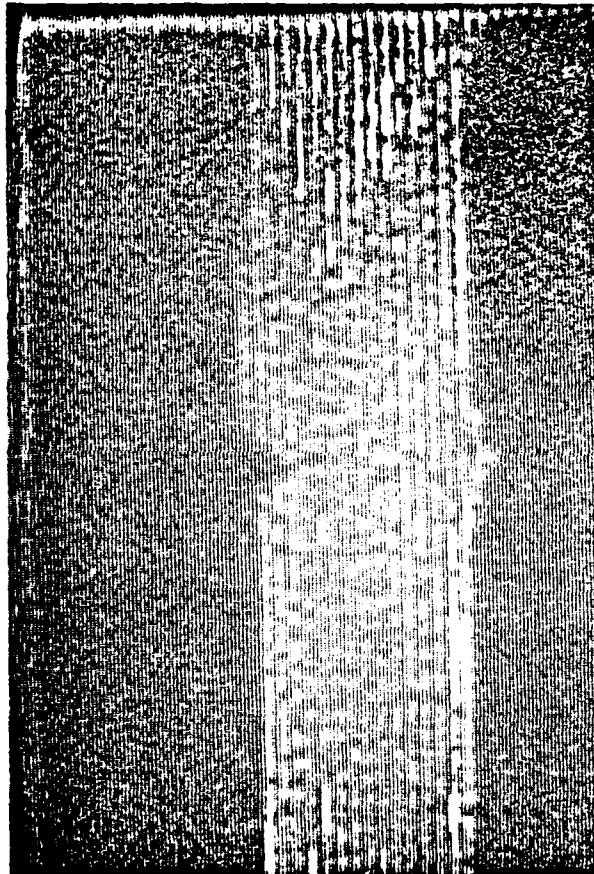
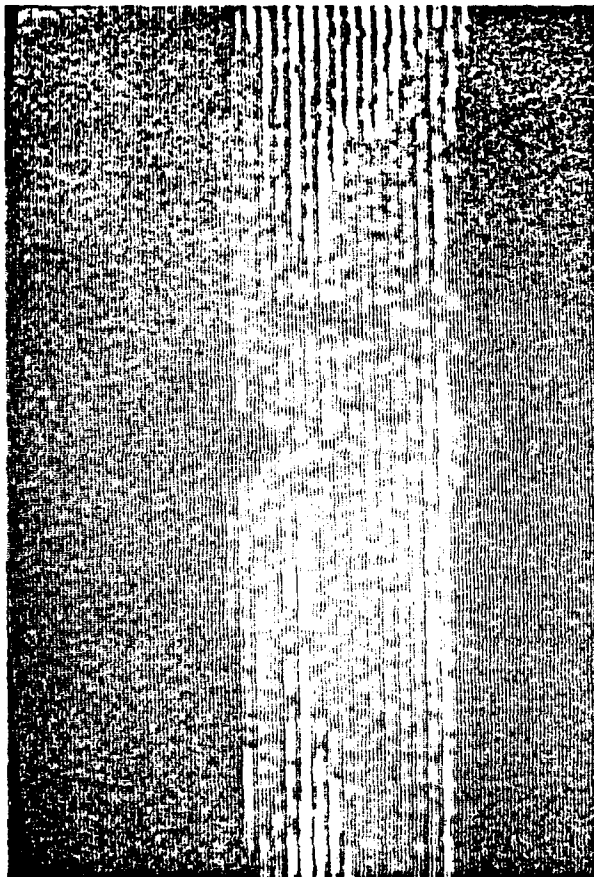
Figure 35A: Photograph of Video Recording of Thermographic Image
Taken just before failure and near maximum load (same
fatigue cycle as 8).

Figure 35B: Photograph of Video Recording of Thermographic Image
Taken just before failure and near minimum load (same as
fatigue cycle A).

Figure 35C: Photograph of Video Recording of Thermographic Image
Taken at the instant of failure.

Figure 35D: Photograph of Video Recording of Thermographic Image
Taken about 1/2 second after failure.

Video-thermography provided some interesting data during the notch fatigue tests. Figure 35A, B, C and D shows thermographs taken during the 210 pound fatigue test performed on specimen 21/4. In order to permanently record thermal changes, a video tape recorder was used to record the image from the thermographic monitor. Later, the tape could be replayed a frame at a time and photographed. This enabled the capture of changes within the framing rate of the thermographic camera (1/16 sec) and within a single fatigue cycle. Figures 35A and B show thermographs taken within the same fatigue cycle, about 1/2 second before failure. Figure 35A was taken near maximum fatigue load which generated heat (indicated by the red color band) on the compression side. Also a colder region (blue) can be noticed along the crack.

Figure 35B shows the top (tension side) to be hotter near the minimum load. This heat is probably generated from friction effects in the crack surfaces. Figures 35C and D show thermographs at the first indication of failure and about 1/10 second thereafter, respectively. Notice the temperature scale at the bottom of Figure 35D. Each color change indicates a change of 0.2°C , the temperature increasing from left to right.

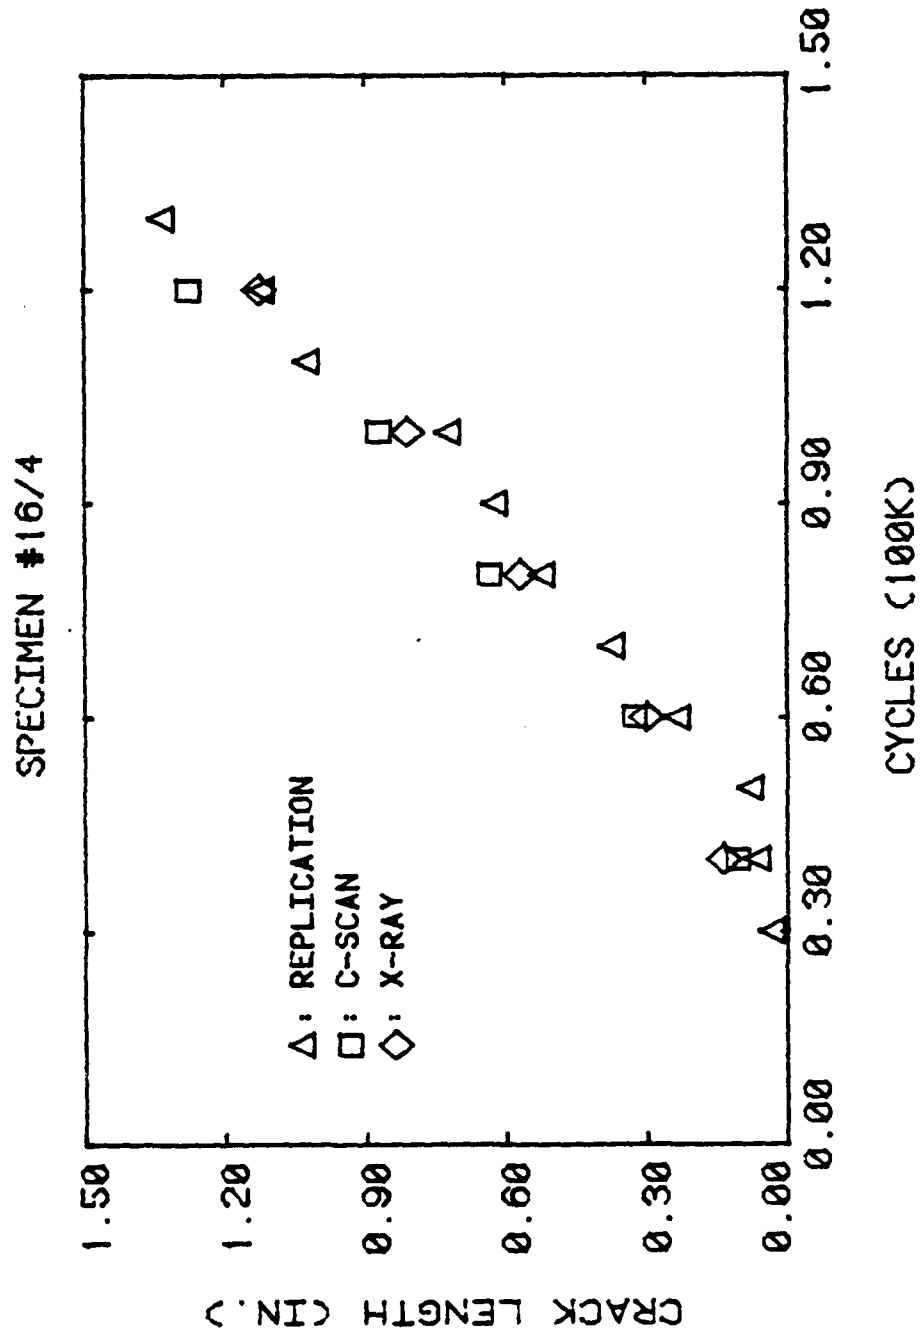
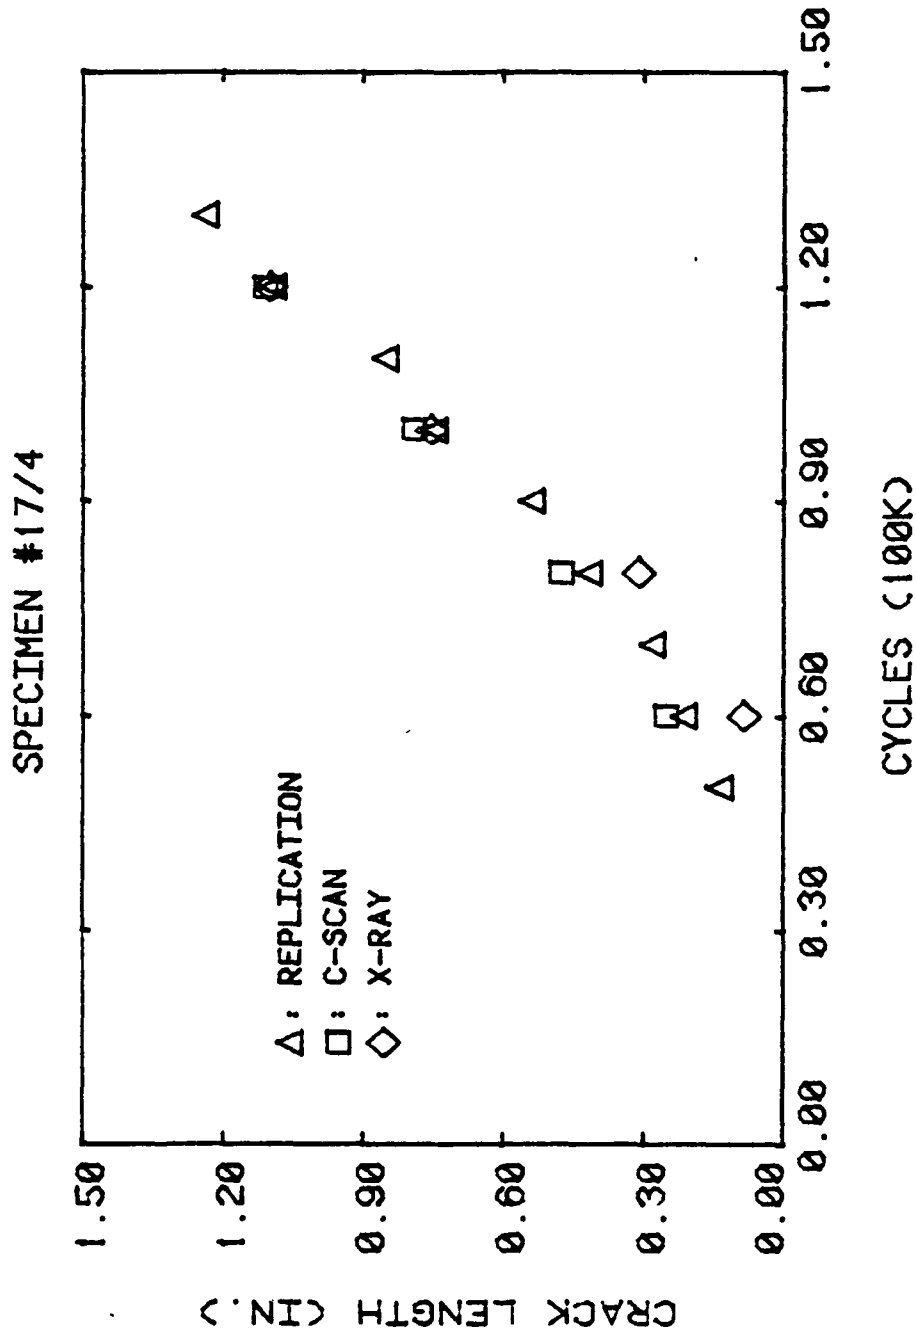
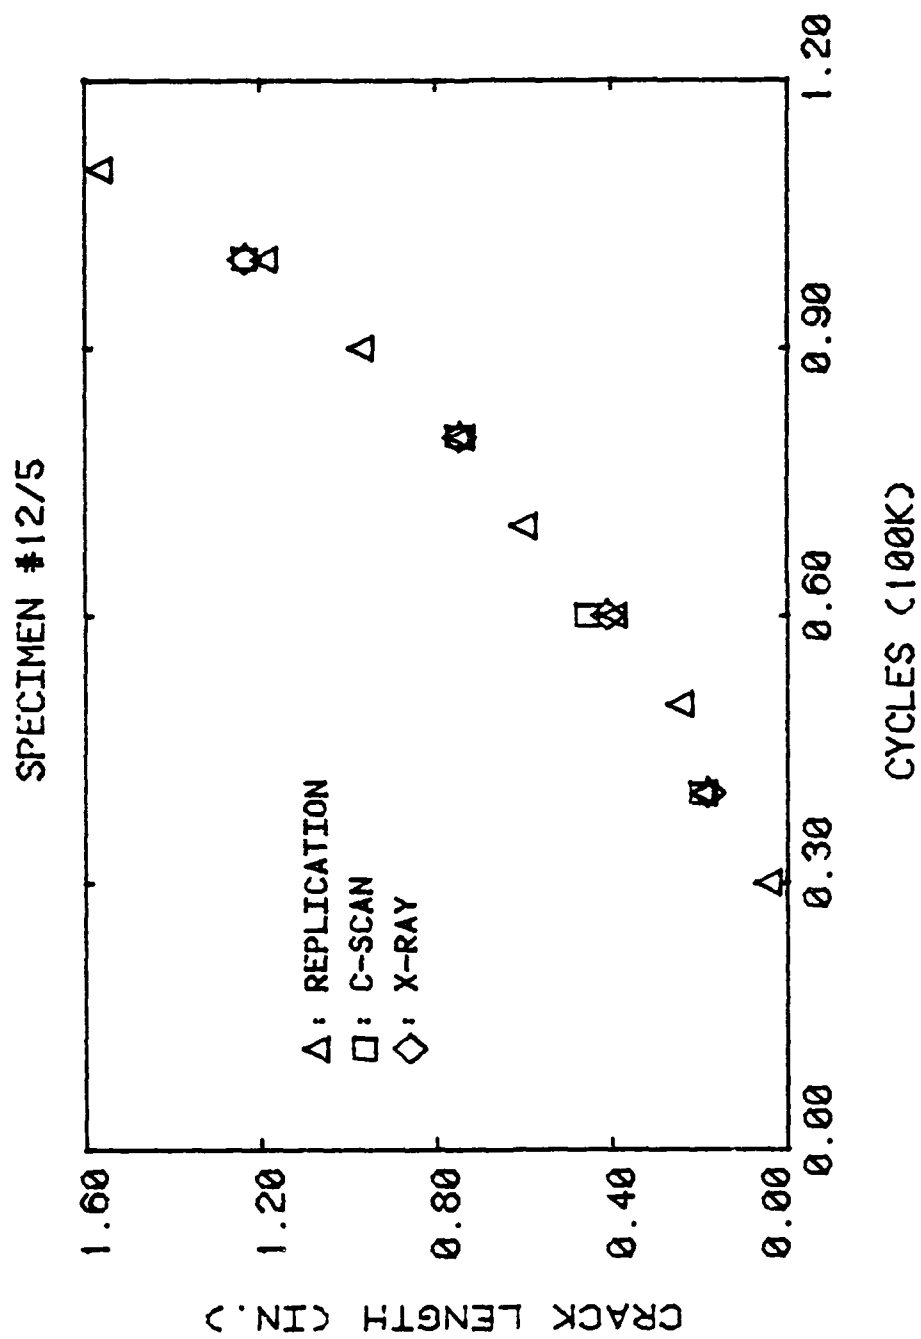
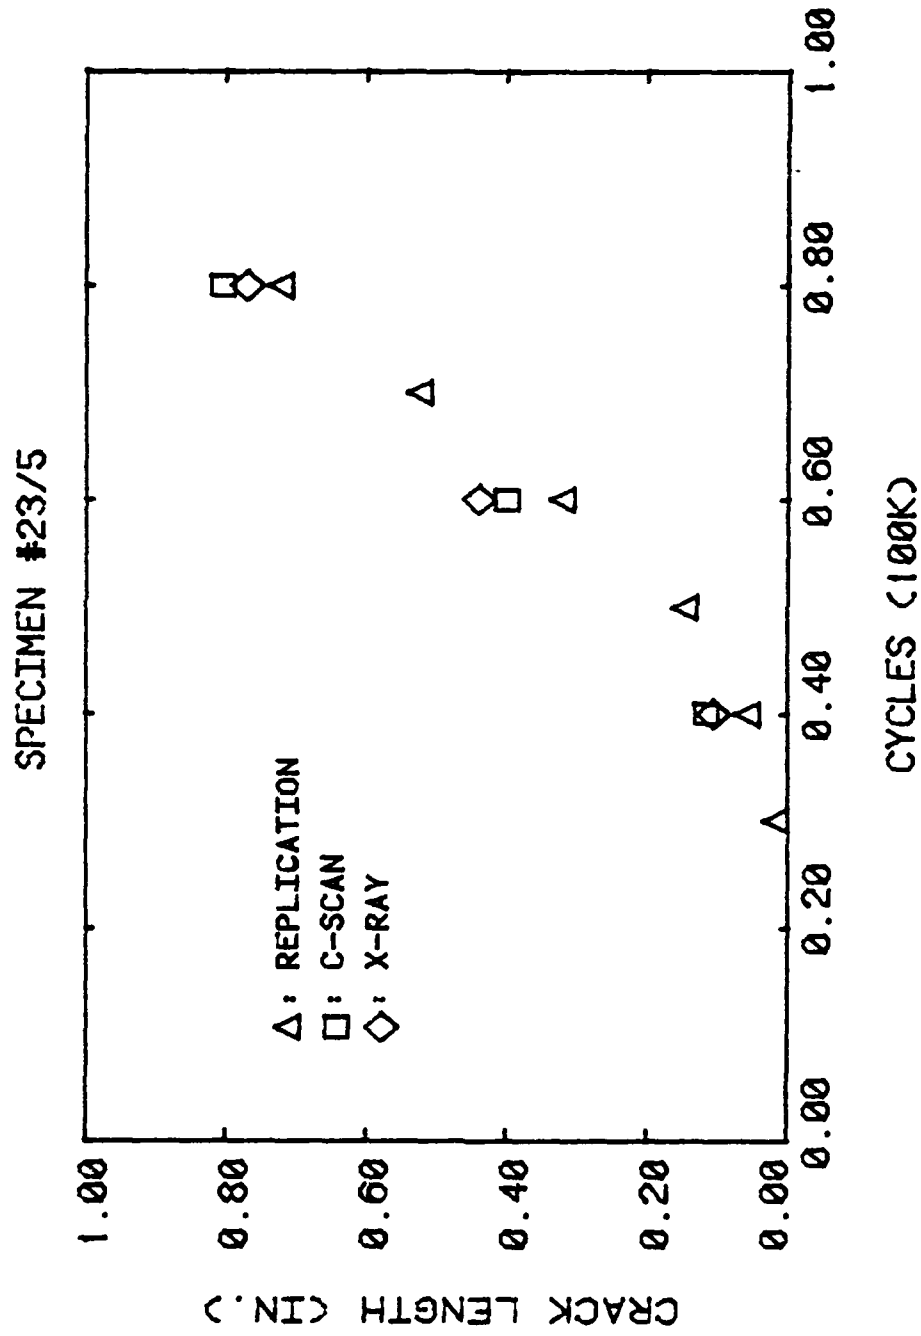
Figure 36: Longitudinal Crack Length detected by three NDE Techniques

Figure 37: Longitudinal Crack Length detected by three NDE Techniques

Figure 38: Longitudinal Crack Length detected by three NDE Techniques

Figure 39: Longitudinal Crack Length detected by three NDE Techniques

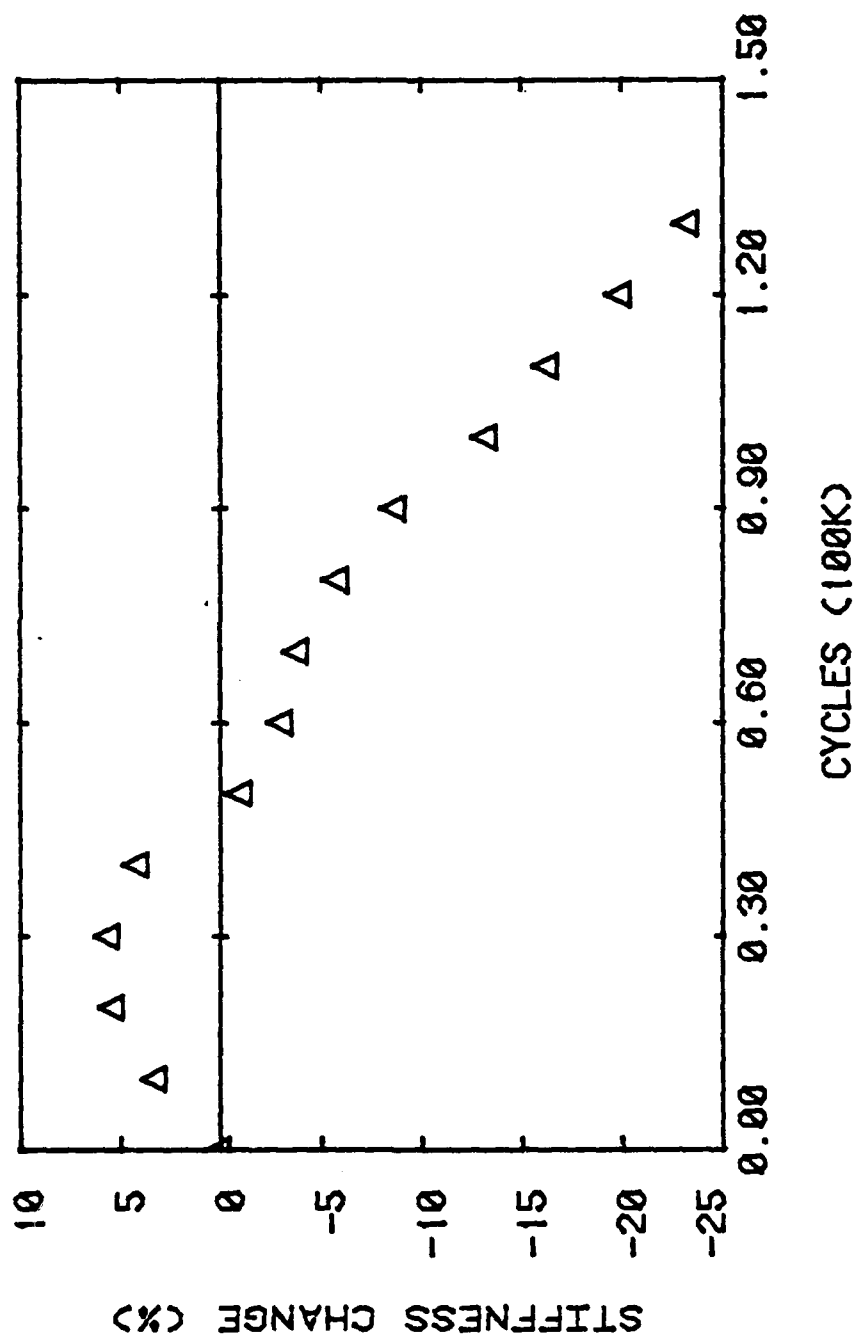
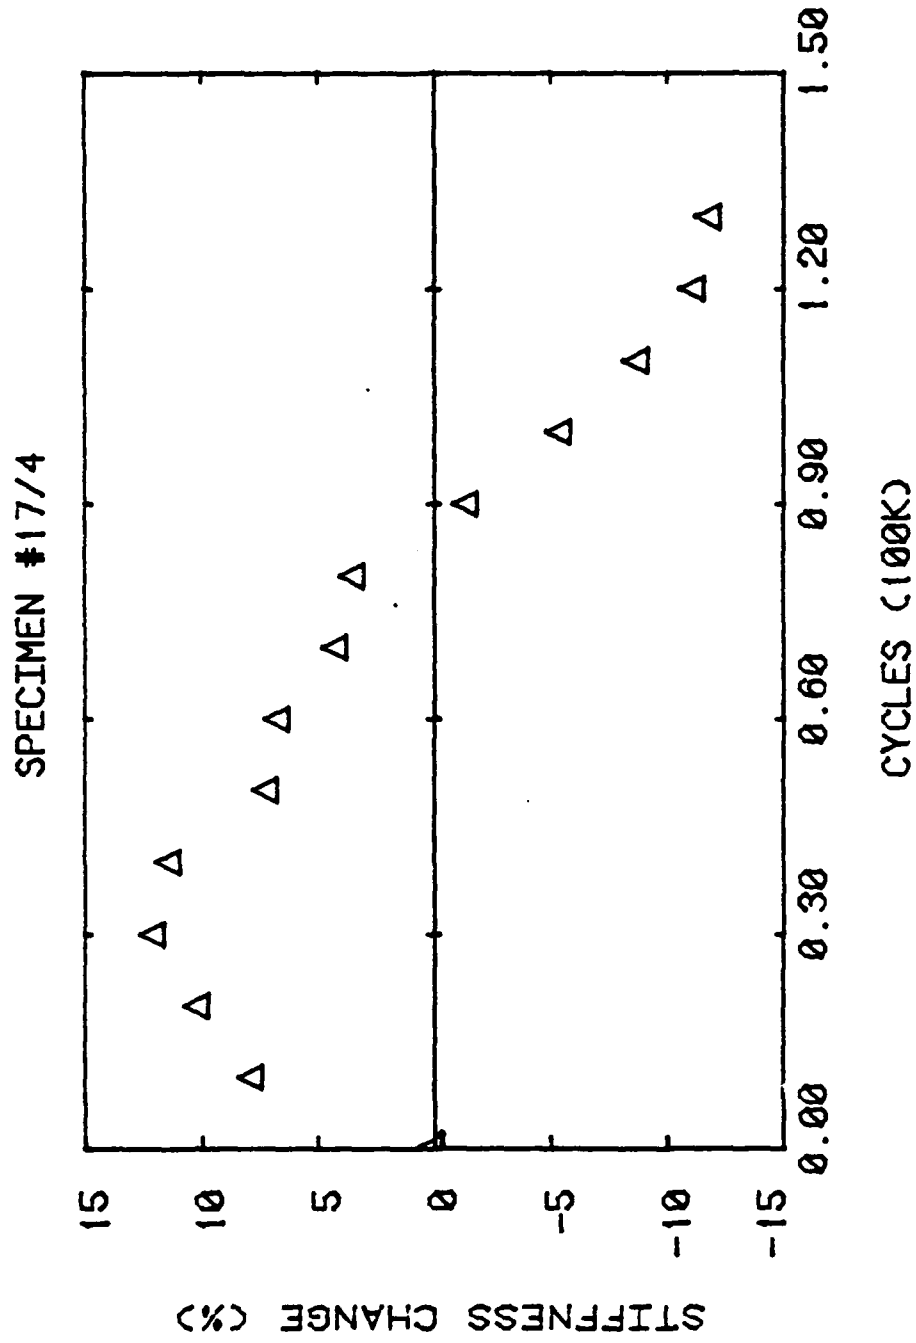
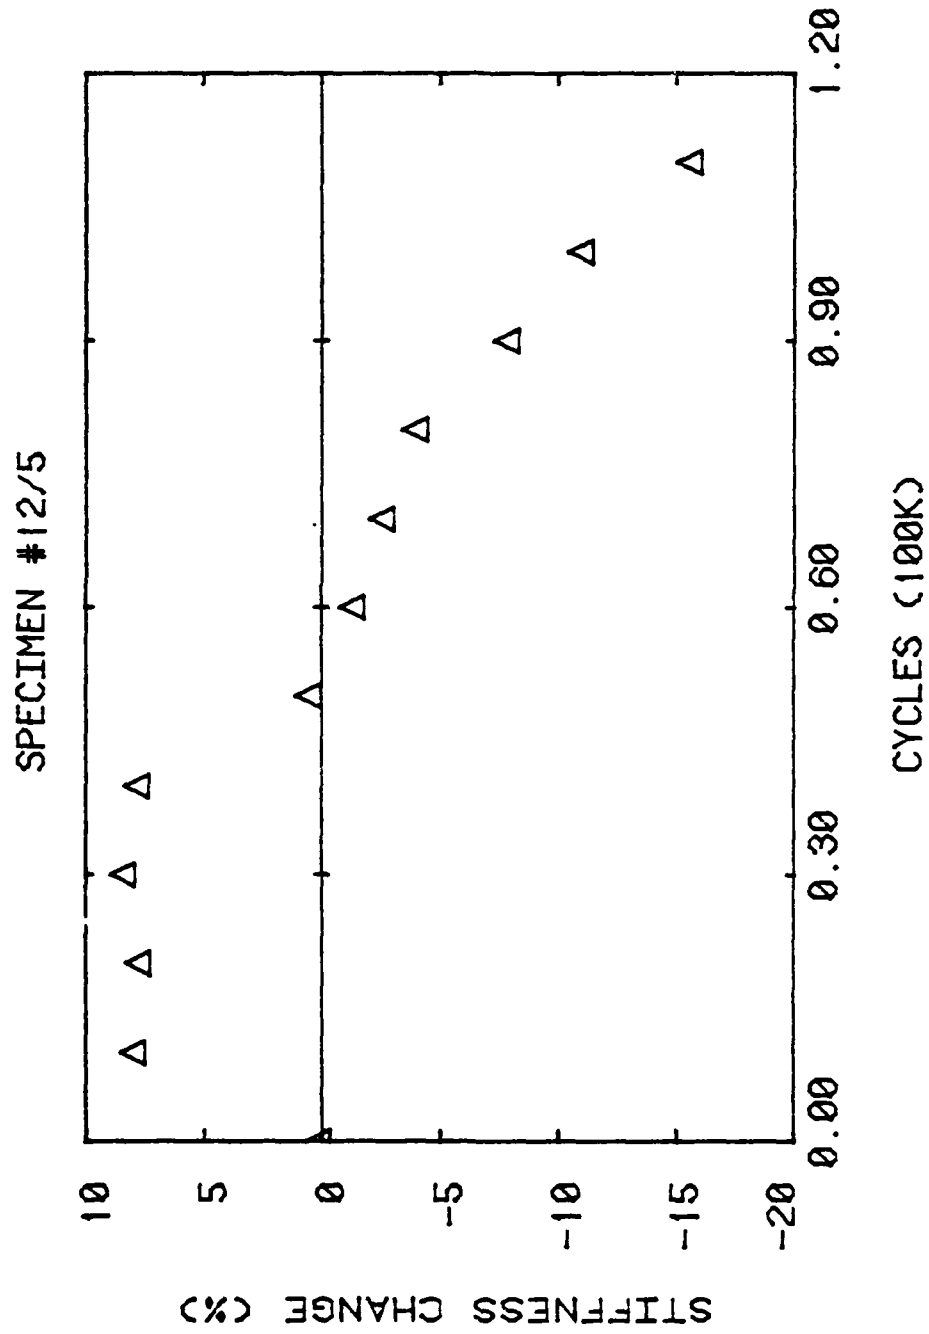
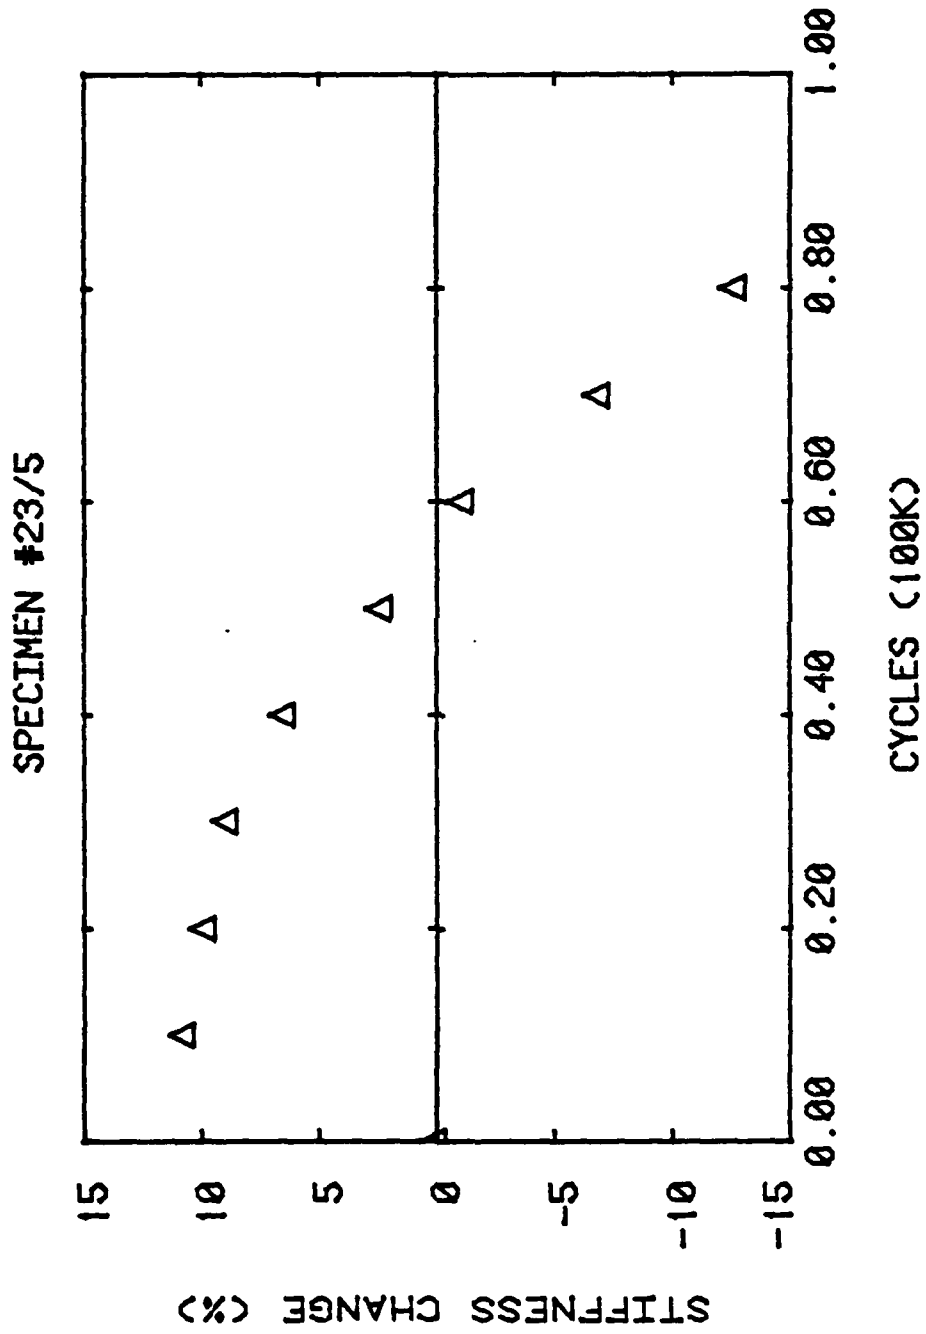
Figure 40: Percent Stiffness Change versus Cycles of Loading in Bend Test

Figure 41: Percent Stiffness Change versus Cycles of Loading in Bend Test

Figure 42: Percent Stiffness Change versus Cycles of Loading in Bend Test

Figure 43: Percent Stiffness Change versus Cycles of Loading in Bend Test

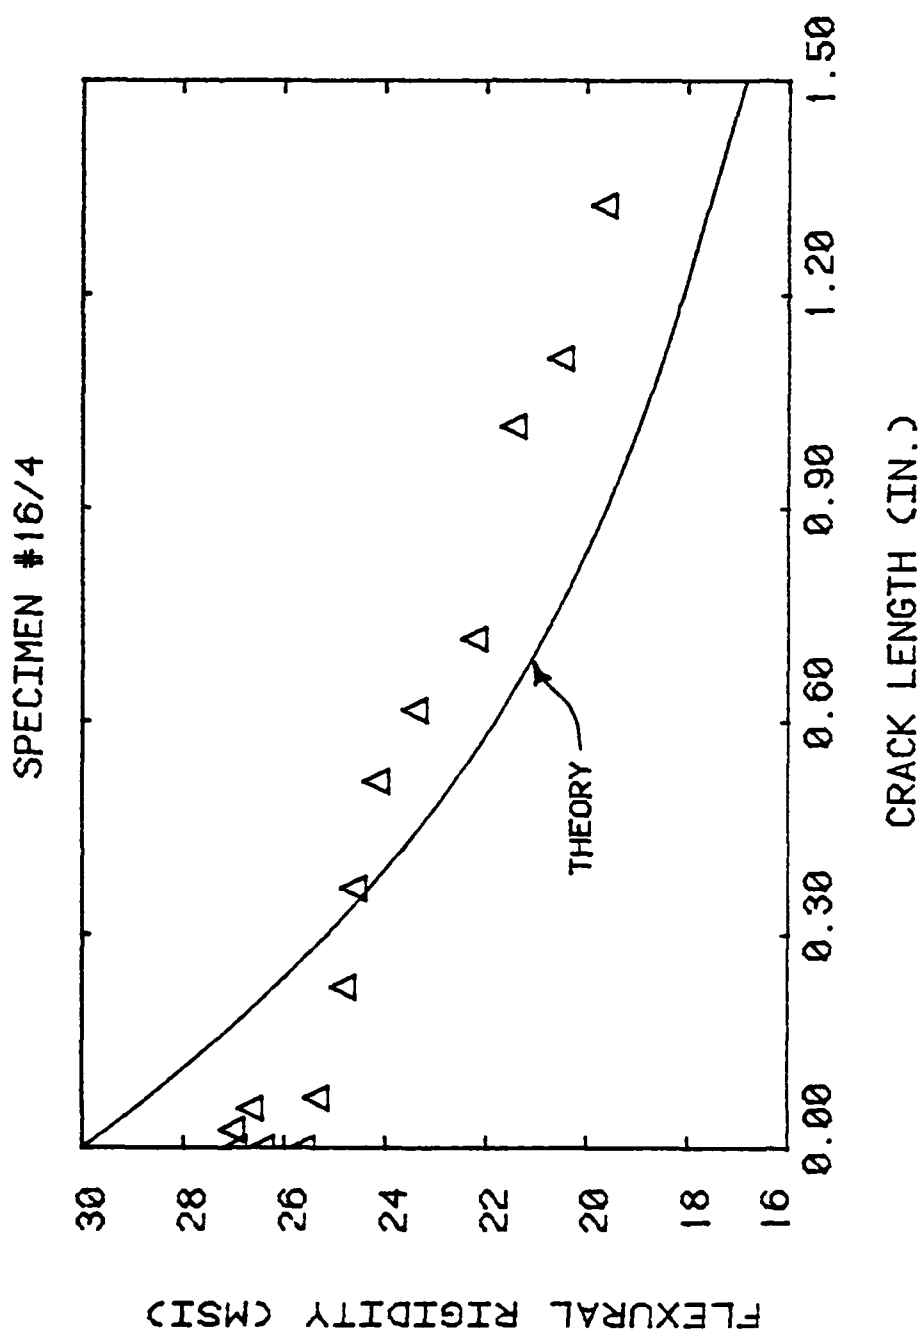
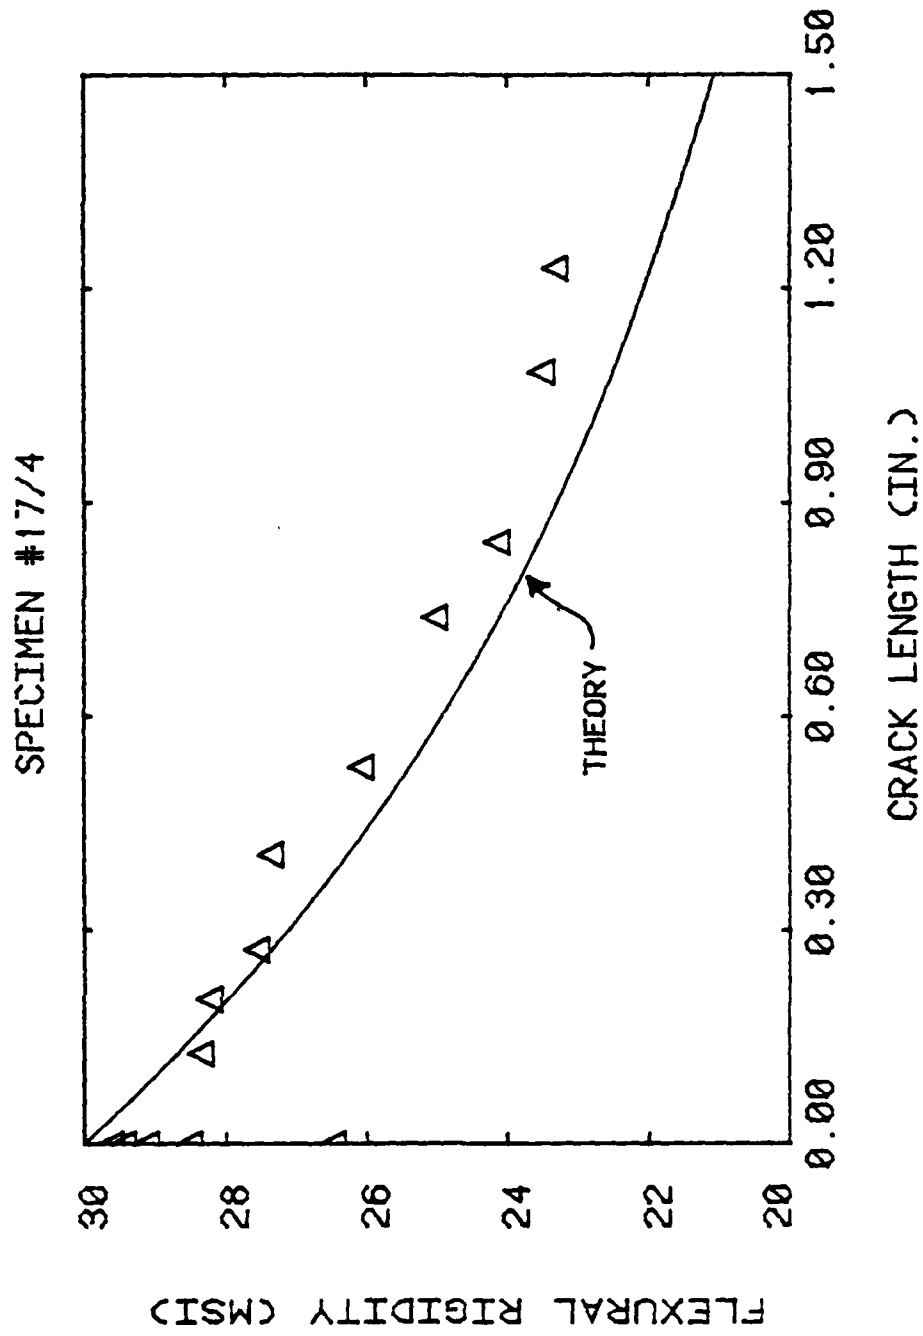
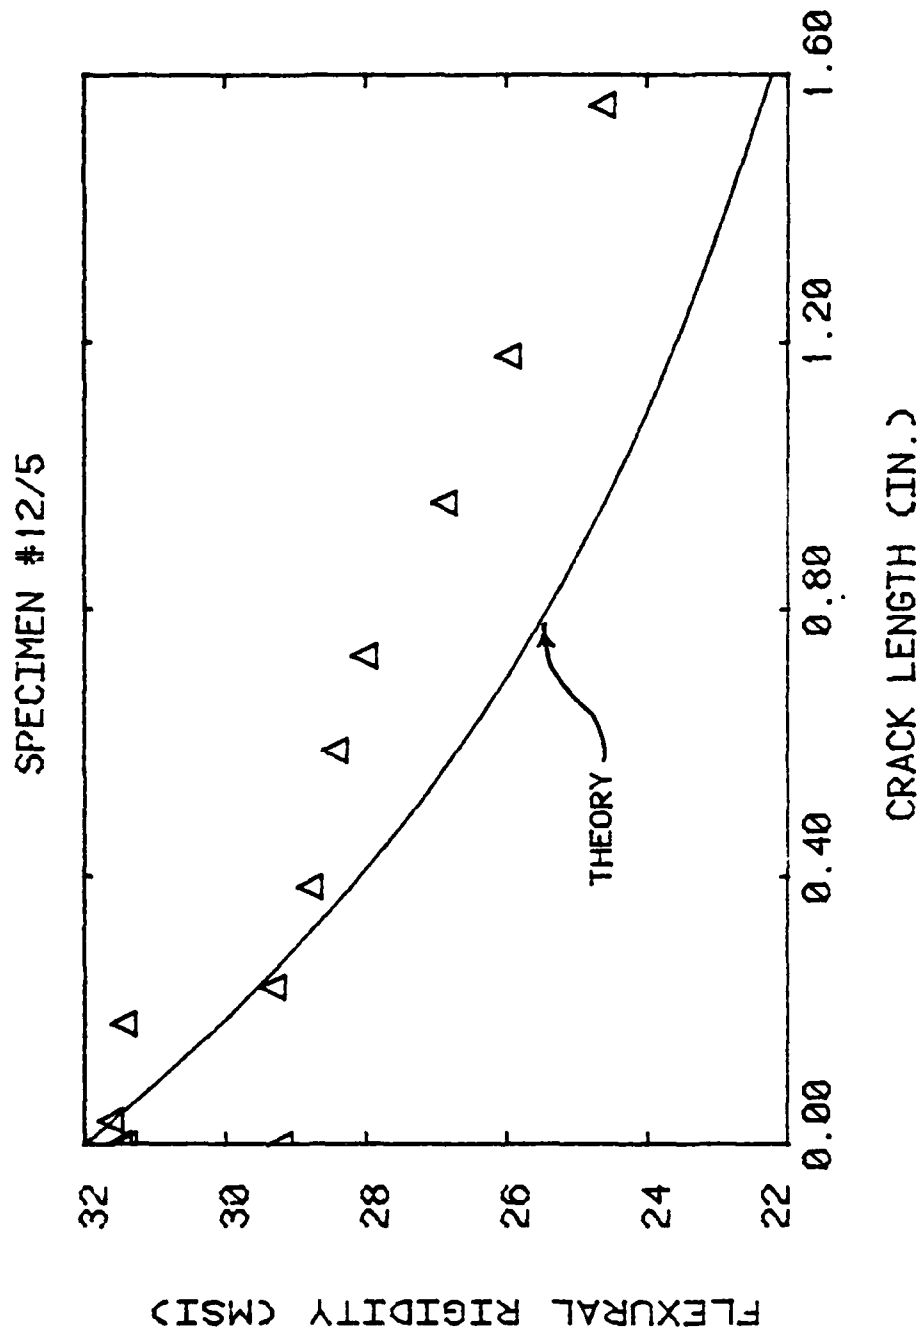
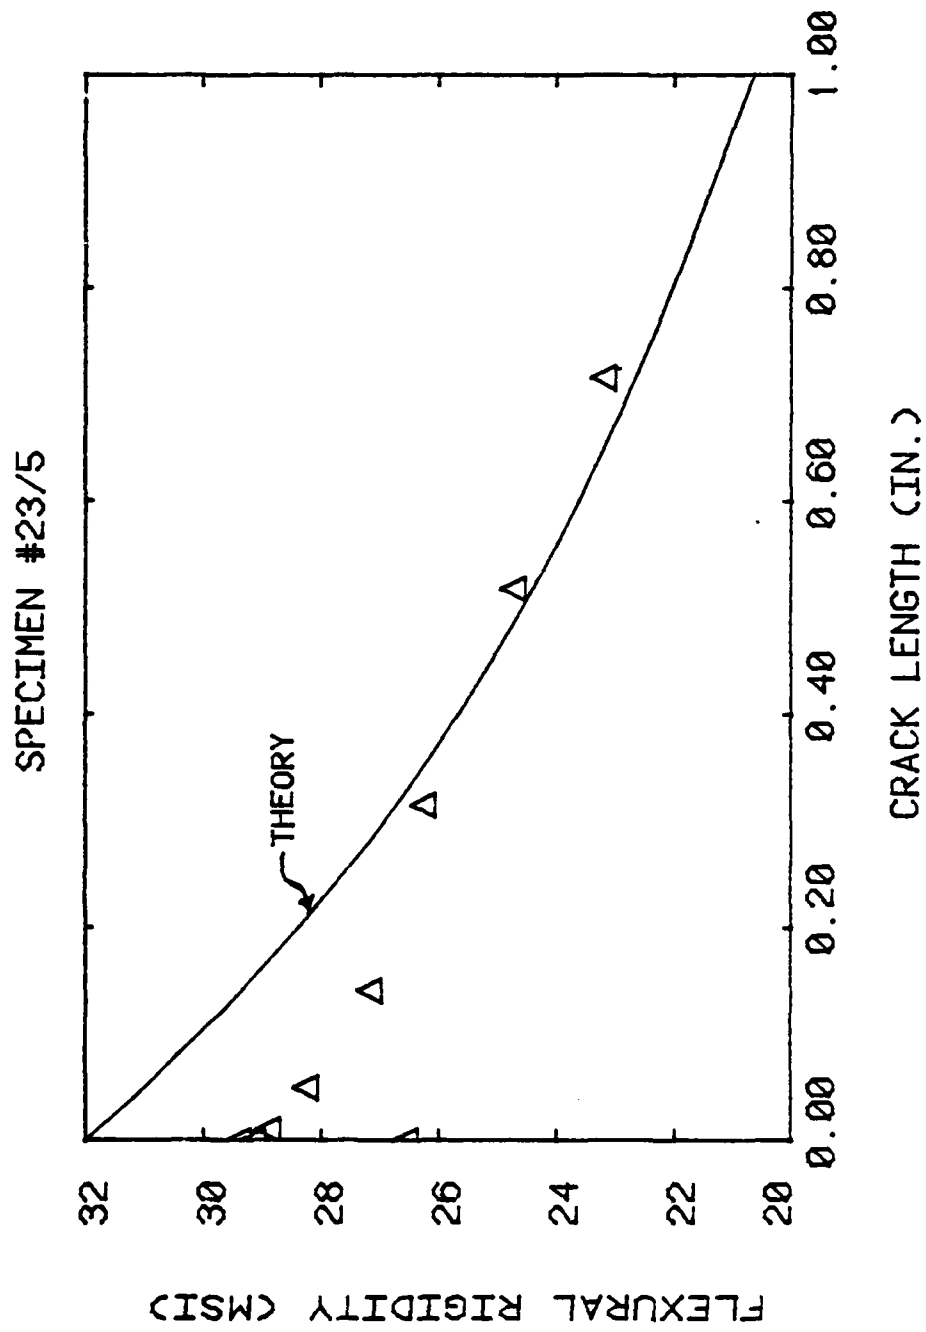
Figure 44: Experimental (points) and Theoretical (line) Stiffness versus Longitudinal Crack Length

Figure 45: Experimental (points) and Theoretical (line) Stiffness versus Longitudinal Crack Length

Figure 46: Experimental (points) and Theoretical (line) Stiffness versus Longitudinal Crack Length

Figure 47: Experimental (points) and Theoretical (line) Stiffness versus Longitudinal Crack Length

I_E is the effective moment of inertia considering the reduction of the beam height by the longitudinal crack depth. Substituting the value of deflection from equation (6) into equation (4), the theoretical curves shown in Figures 44 through 47 are developed. These curves show the

theoretical flexural stiffness reduction due to the reduction of the effective moment of inertia of the beam. The modulus of the material, in equation (6), is assumed to be 30 Msi and 32 Msi for 45% V_f and 55% V_f , respectively. Note that this does not account for the stiffness increase that occurred in all specimens due to matrix work hardening. This may be one reason why the experimental points are slightly higher than the theory. However, the relationship between theory and experiment shows that stiffness change can be used not only to detect damage but to quantify the extent of damage development.

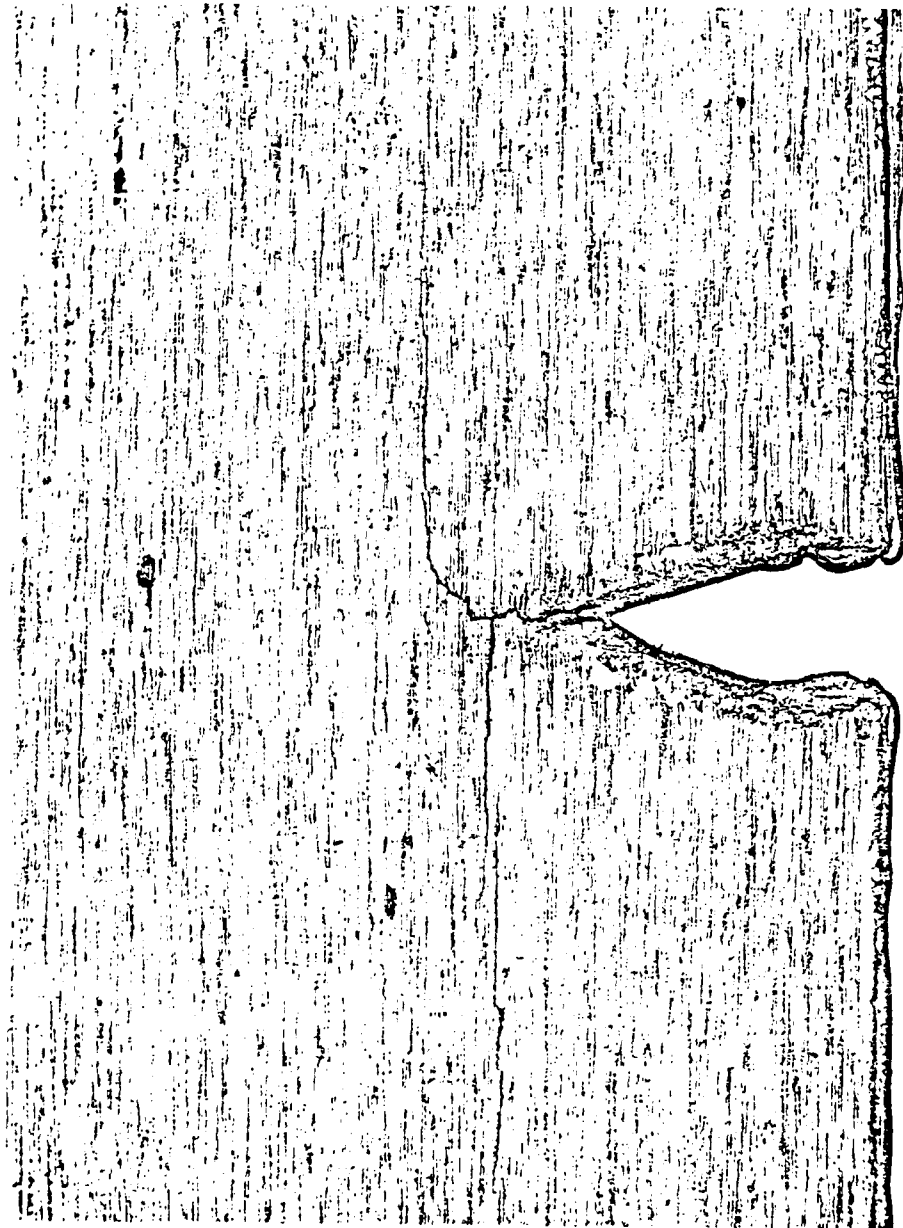
Figure 51: Reproduction of Edge Replica of Specimen 23/5 after 60K Cycles (24X)

that the side with the deeper crack quickly slanted back to the same depth as the other side. Figures 52, 53 and 54 show transverse cracks between the notch and the longitudinal crack for specimens 12/5, 16/4 and 17/4, respectively. Table 16 lists the notch depth and maximum and minimum bounds on longitudinal crack depth and transverse crack length. The crack depth measurements are taken from sections of the failure surface and the transverse crack length calculated as the difference of the longitudinal crack depth and the notch depth. Maximum and minimum values are given because of the variance in longitudinal crack depth across the surface. The table also indicates that the transverse cracks were about 0.005 to 0.010 inches long. The high value of maximum transverse crack length for specimen 23/5 is due to the discontinuity shown in Figure 51.

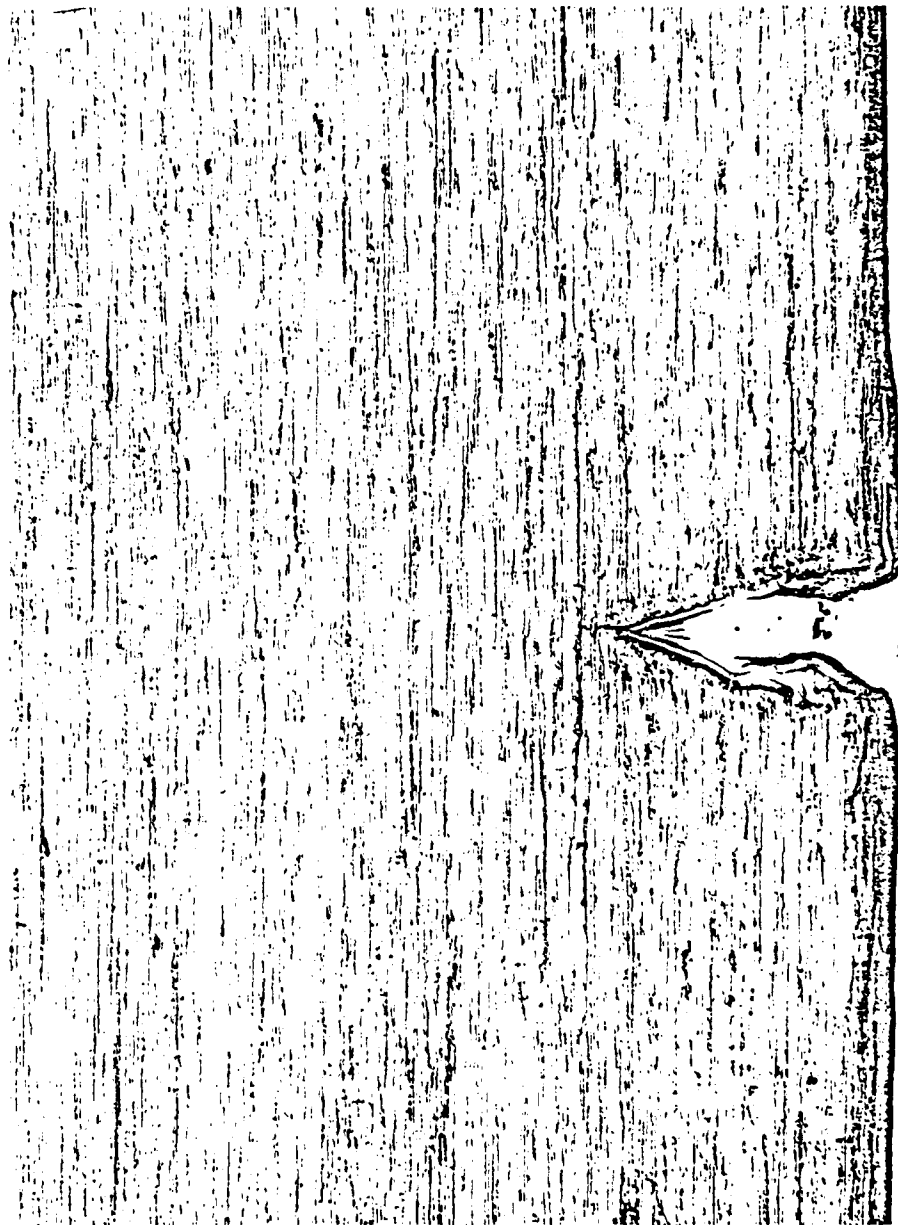
Figure 54: Reproduction of Edge Replica of Specimen 17/4 after 60K Cycles (24X)

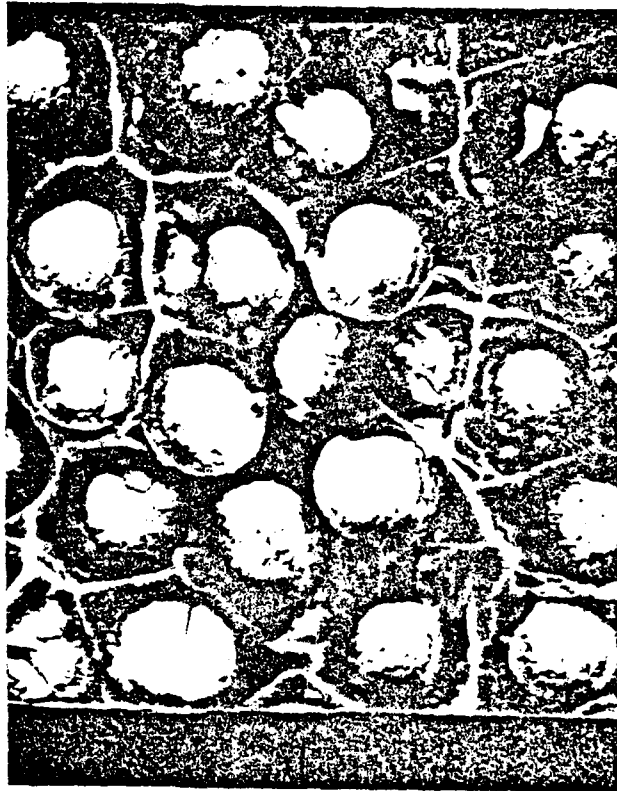
Figure 55: Matrix Void found on the catastrophic failure surface of specimen 21/5 (1000X)

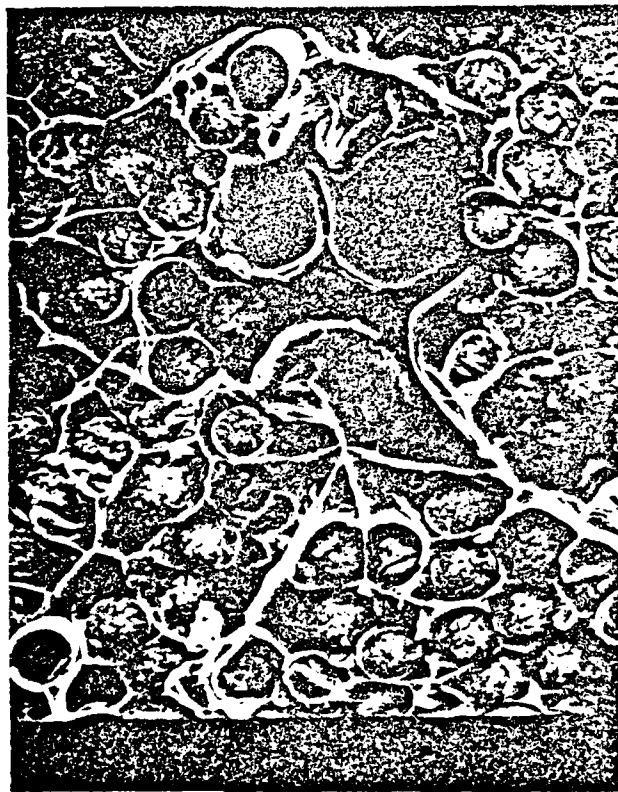
Figure 56: Matrix Rich Region with an interior void found in the catastrophic failure region of specimen 3/4 (500X)

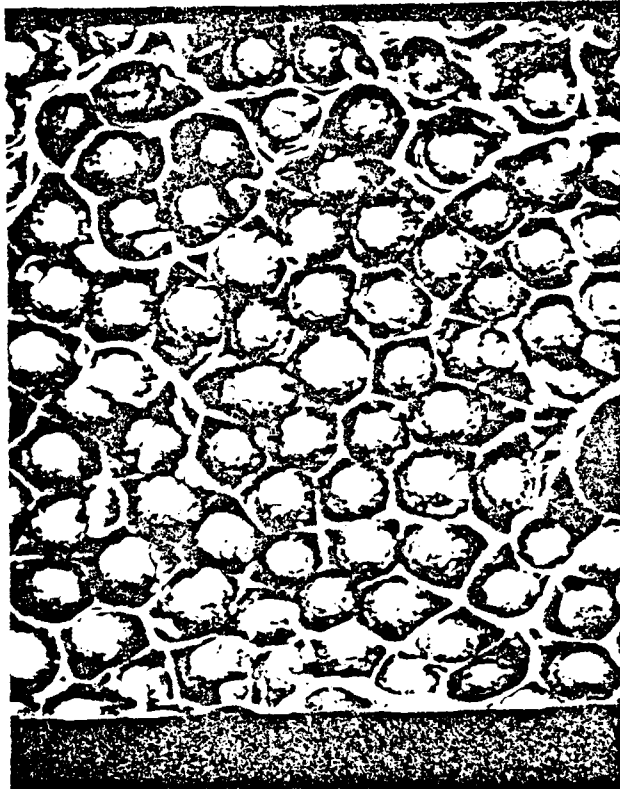
Figure 57: Catastrophic Failure Surface of specimen 21/6 (500X)

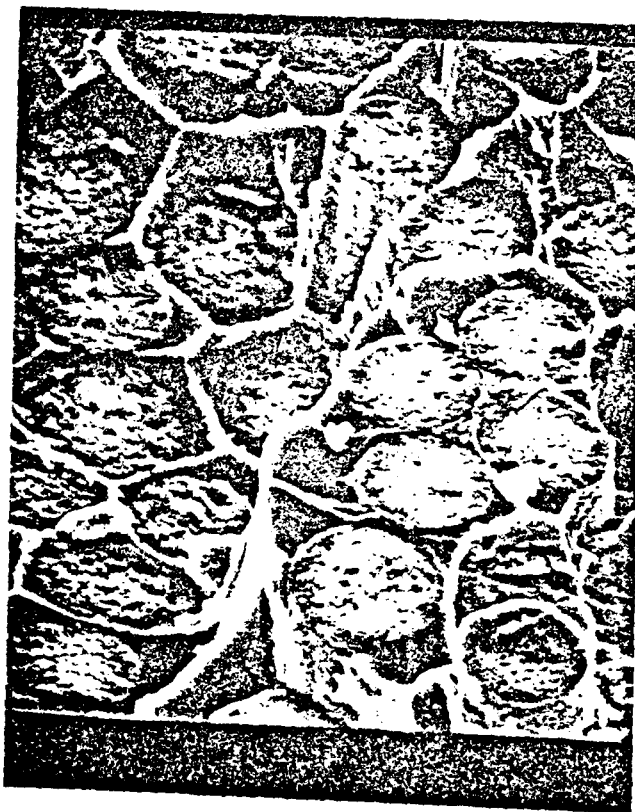
Figure 58: Ductile matrix behavior during catastrophic failure found on specimen 15/5 (1000X)

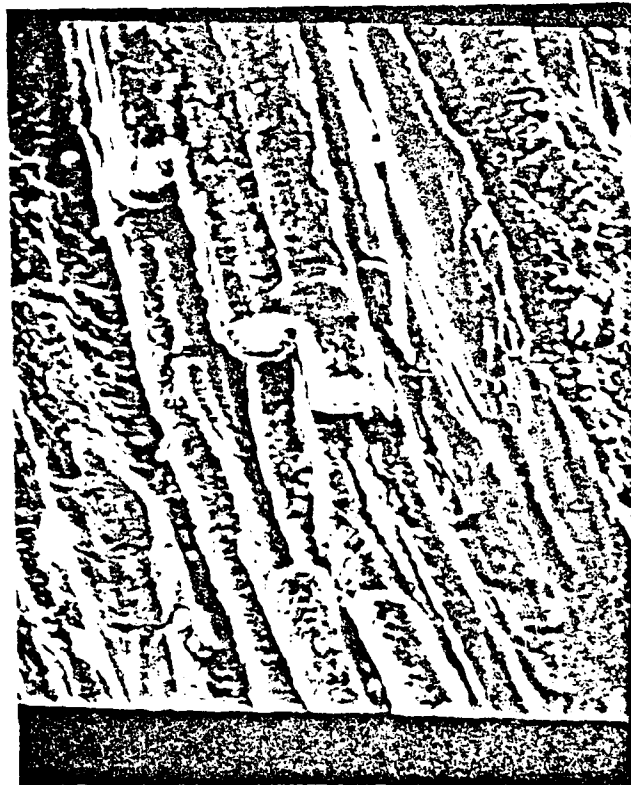
Figure 59: Longitudinal fatigue crack found on specimen 21/5 (500X)

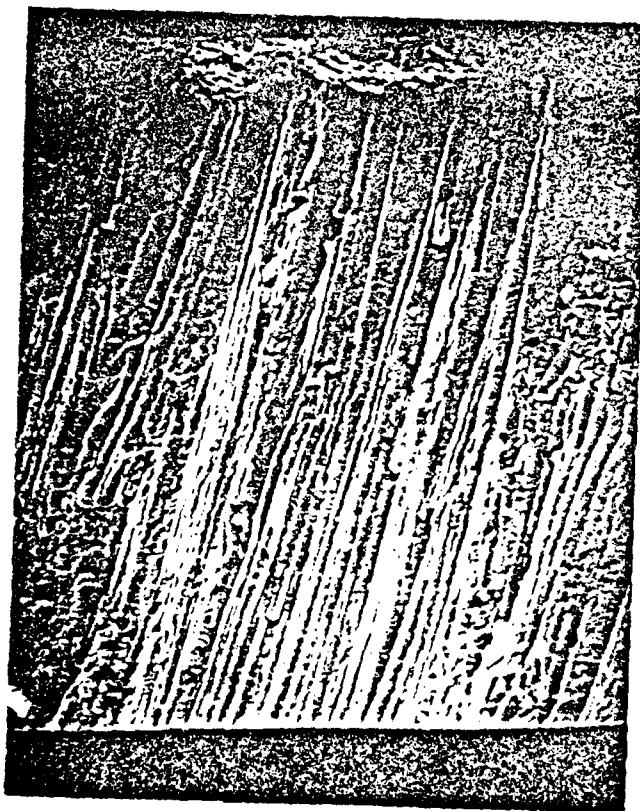
Figure 60: Longitudinal Fatigue Crack found on specimen 21/5 (100X)

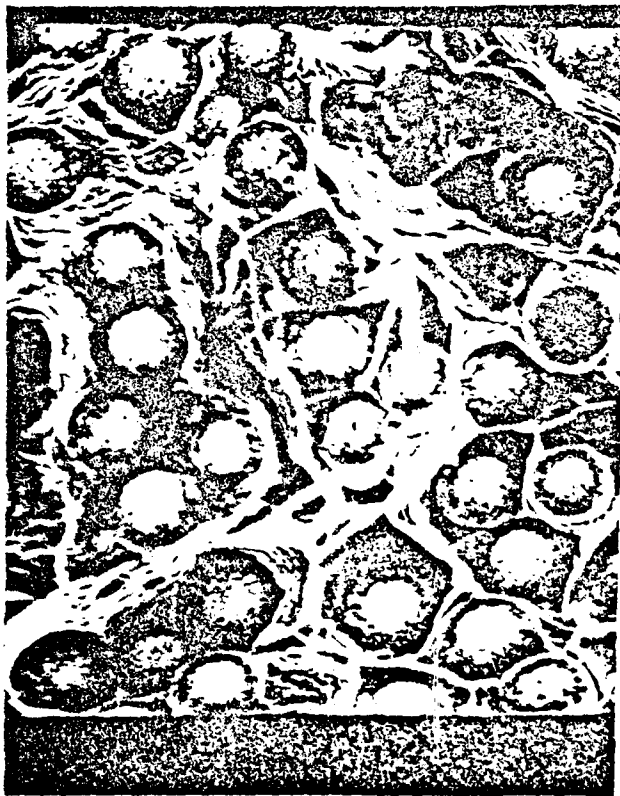
Figure 61: Ductile Matrix Failure (lower left) separated from a Fatigue Crack Failure zone by what appears to be a Matrix Crack, found on specimen 9/4 near tensile edge. (700X)
